FOURTH ENDORSEMENT on VF-121 AAR ser 6-58 concerning TV-2 BUNO 136834
accident occurring 22 September 1958, pilot GONZALEZ

FIRST ENDORSEMENT on VF-121 AAR Serial 6-58 concerning TV-2, BuNo. 136834
accident occurring 22 September 1958, Pilot GONZALEZ

Subj: VF 121 AAR 6-58.

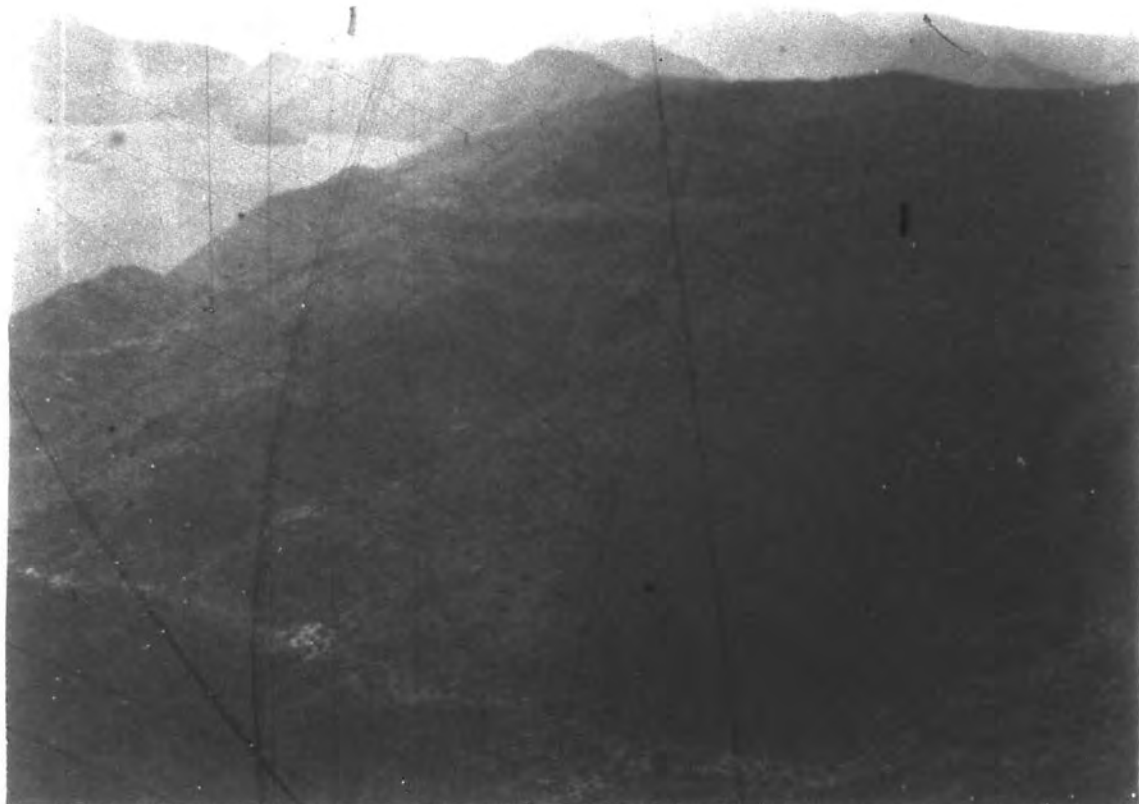
ENCLOSURE 4A VF-121 AAR 6-58

POINT OF IMPACT. Heading of Aircraft upon impact, approximately 240°.

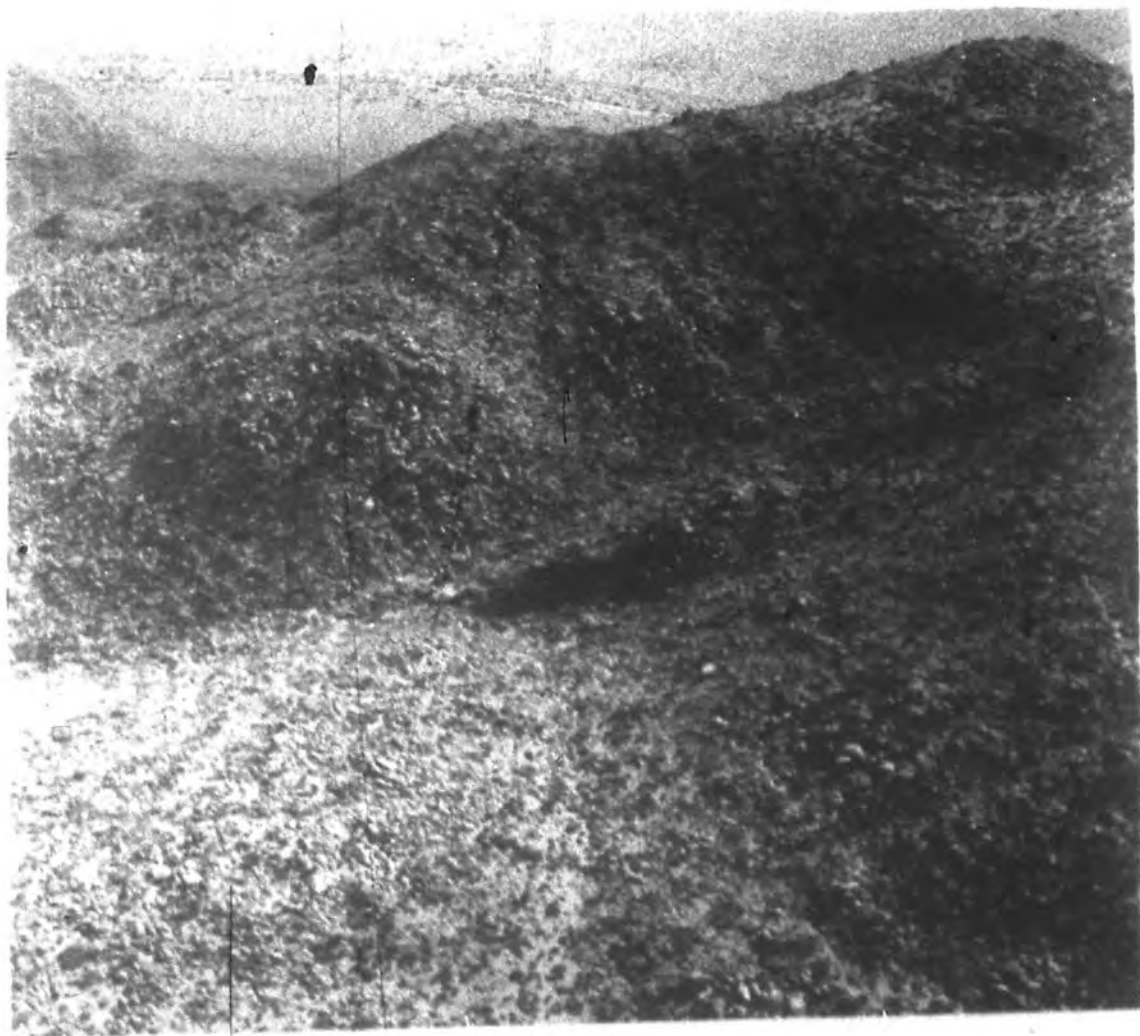
ENCLOSURE 4B VF-121 AAR 6-58
CLOSE UP AERIAL PHOTO OF CRASH SCENE. Initial impact to the left of
burned area. Fire result of impact.

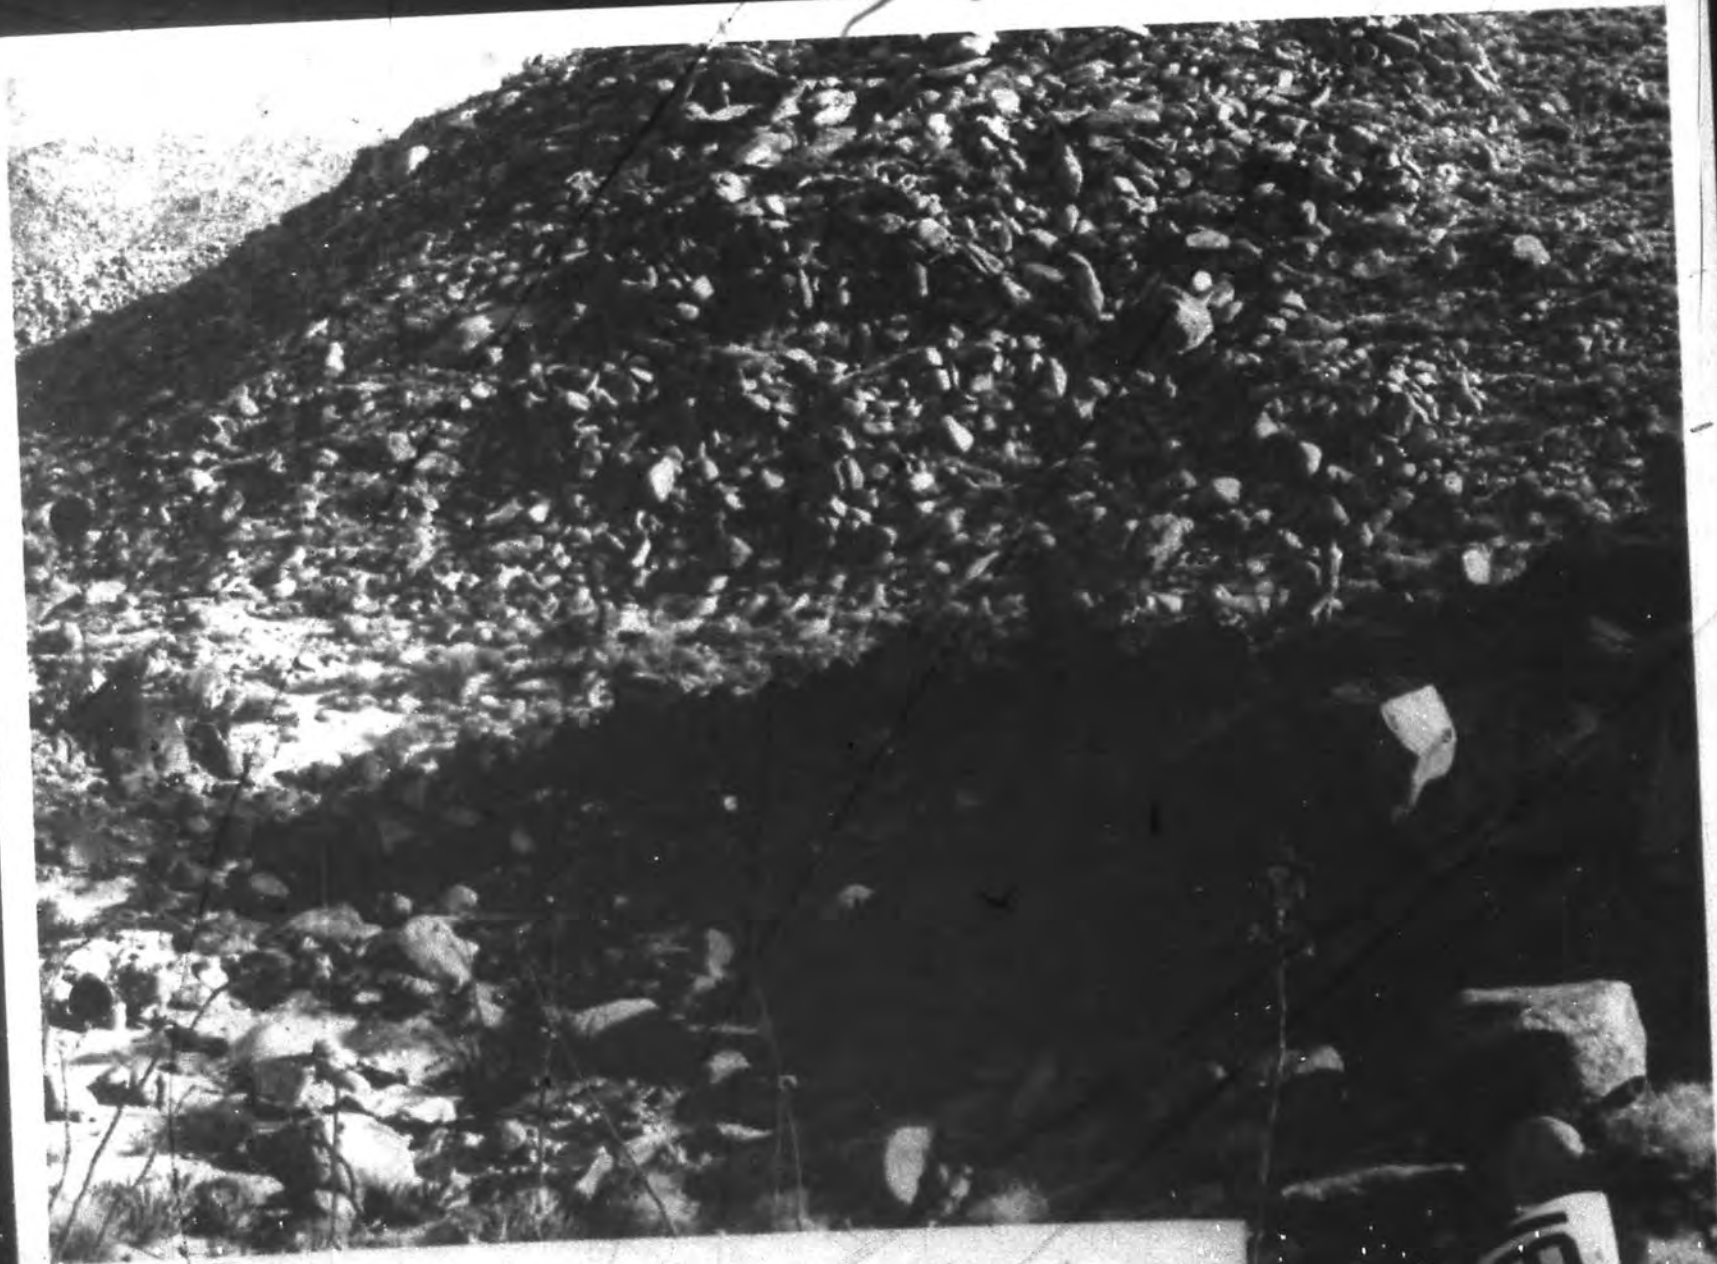
ENCLOSURE 10 VF-121 AAR 6-58

IMPACT AREA OF CRASH. Note initial impact to the left, empennage and final position right center, clamshell nose section door in foreground.
